Stony Creek Concerned Citizens: Coastal Vulnerability and Village Planning Group

Rail Underpass Catch Basin Issue

May 2, 2019

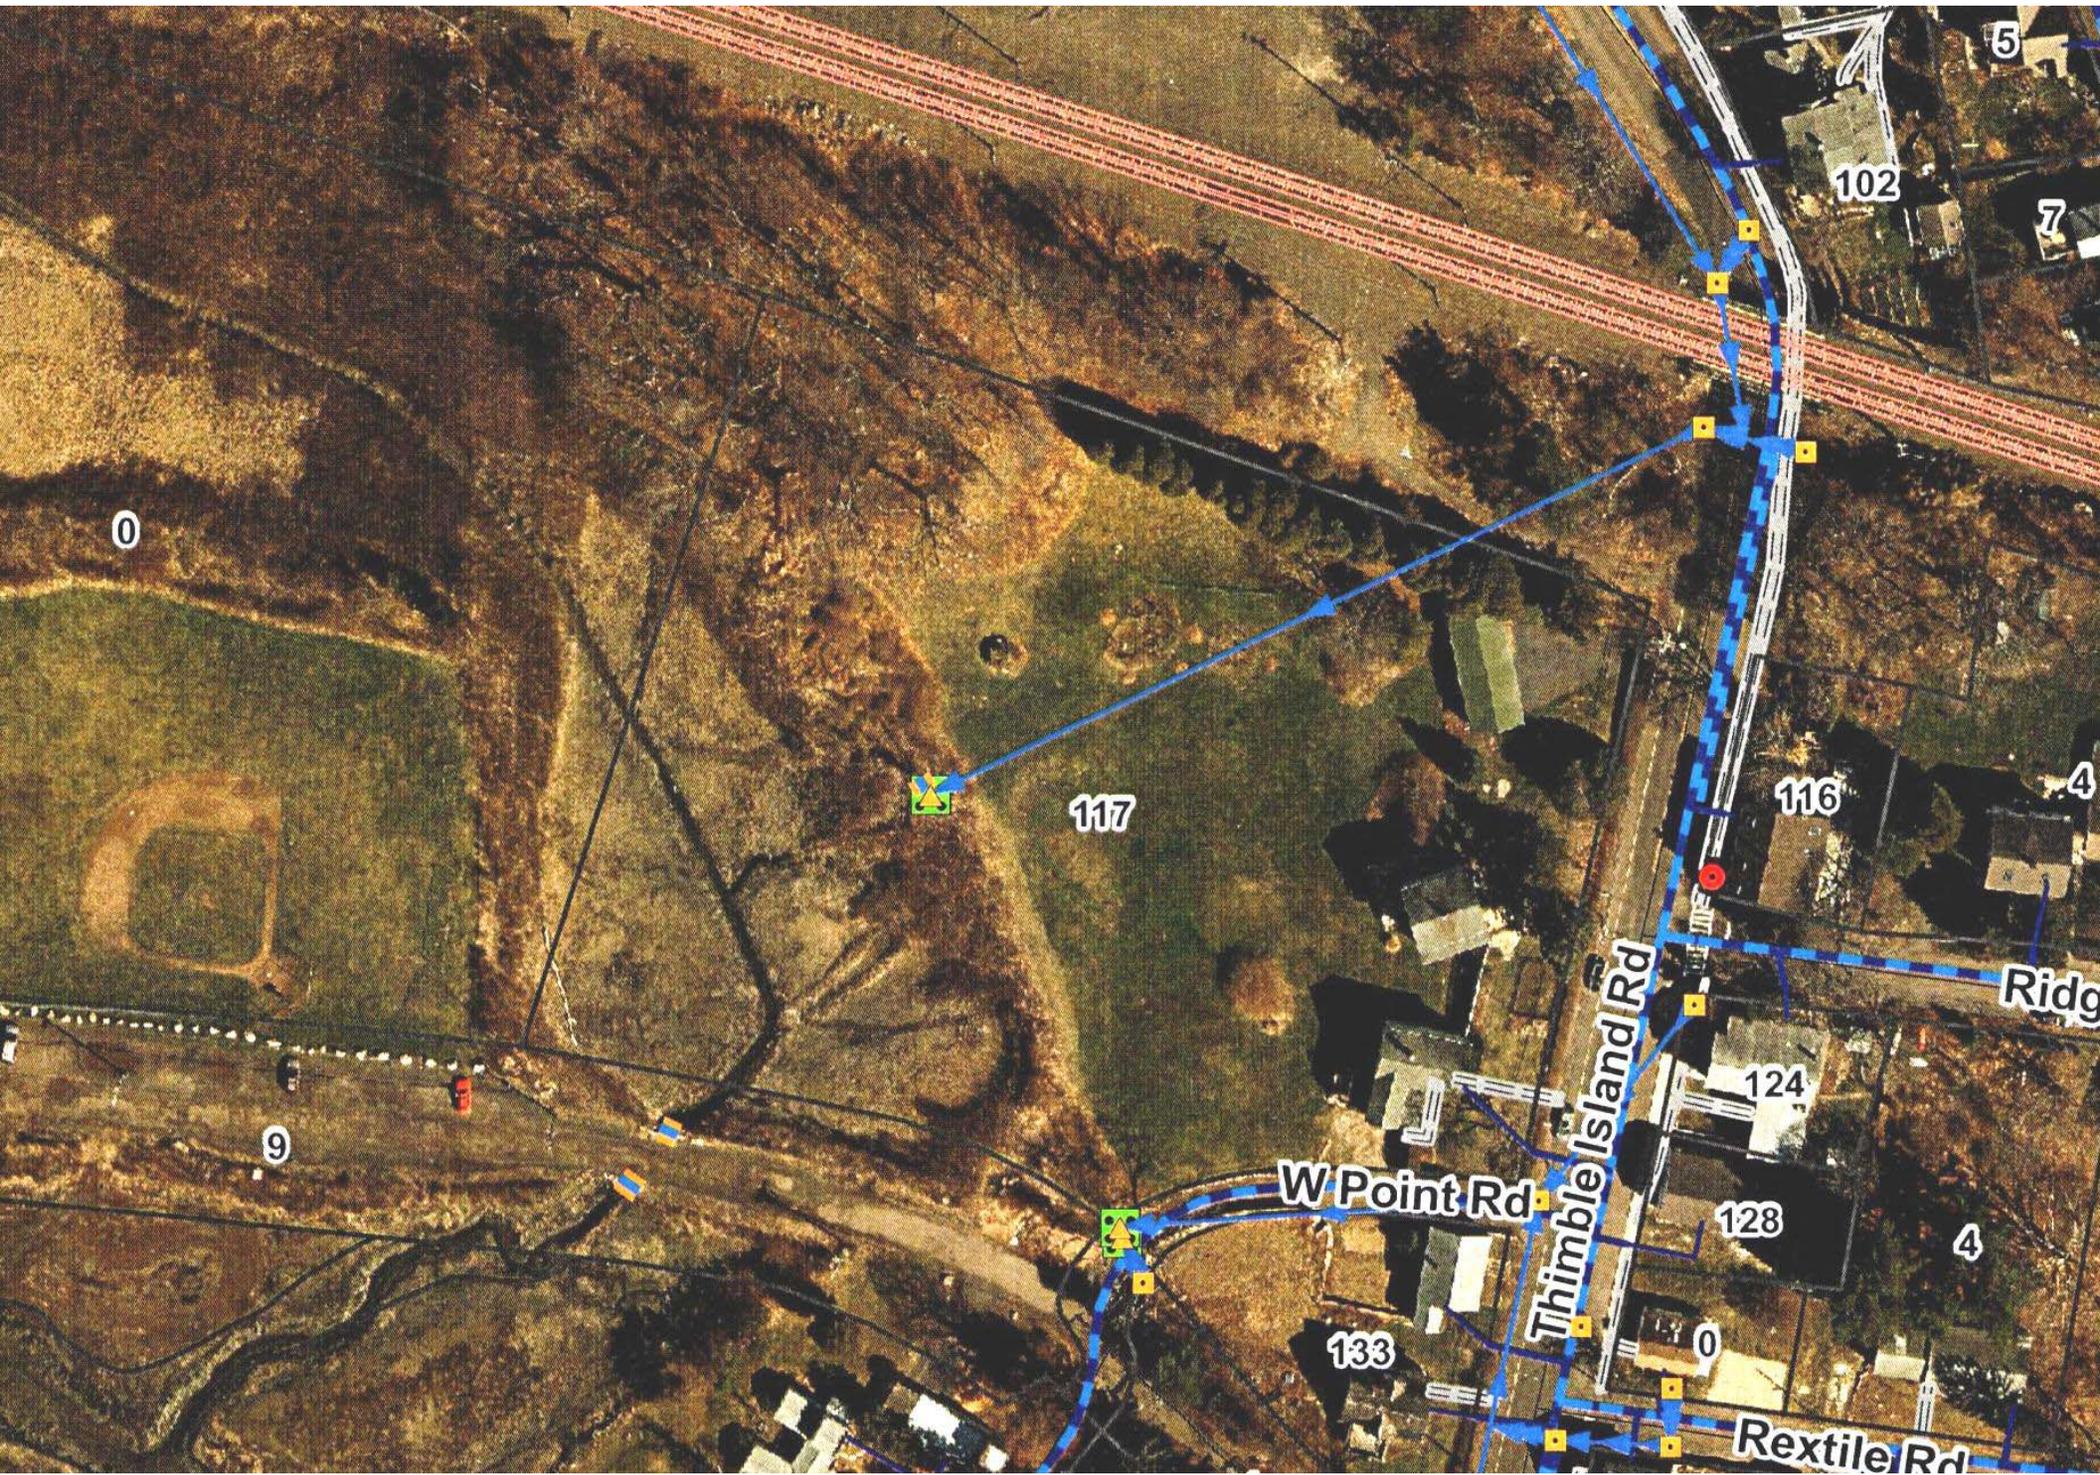
The catch basin under the rail overpass is connected to a 15" corrugated steel pipe running under the property of Joan Johnson and out into the marsh behind the ball field. See attached plan from the GIS system. The town has not been able to find the outlet structure and has not inspected the pipe to see if it has collapsed or is clogged.
